FRA Presentation of BRC Leak June 2020

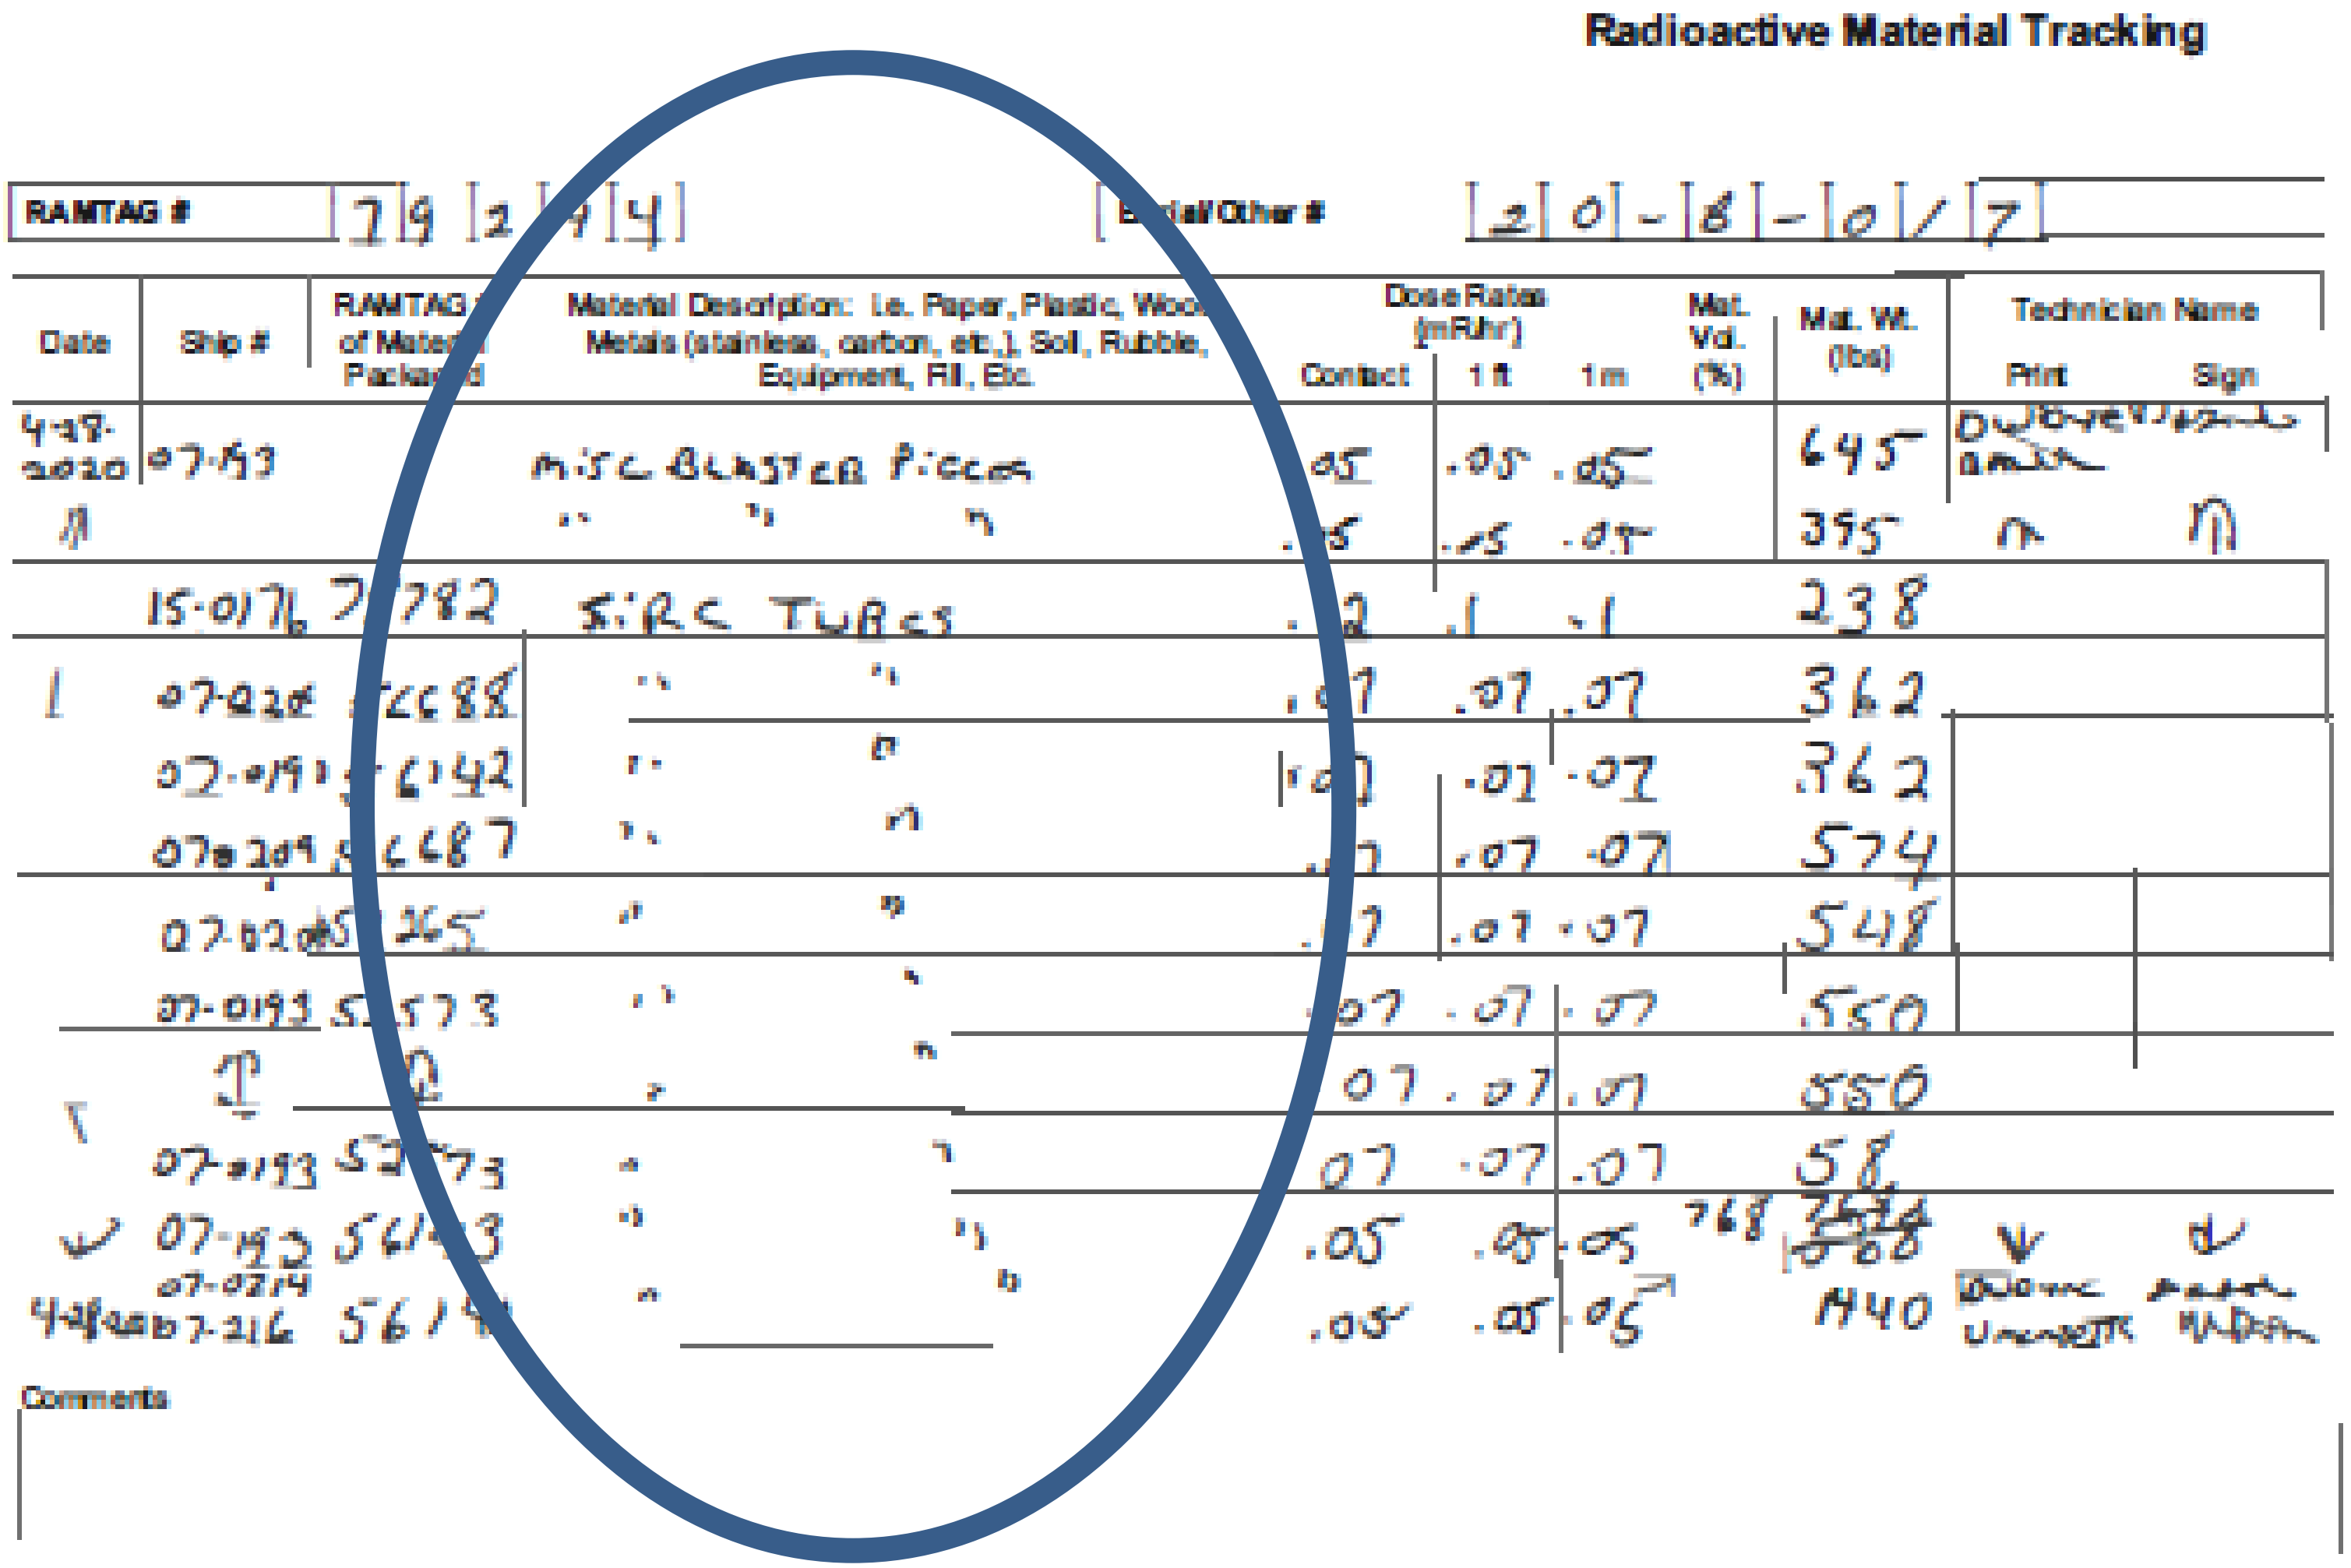
The nonhazardous contents provided by the shipper included a large quantity of Zirc Tubes.

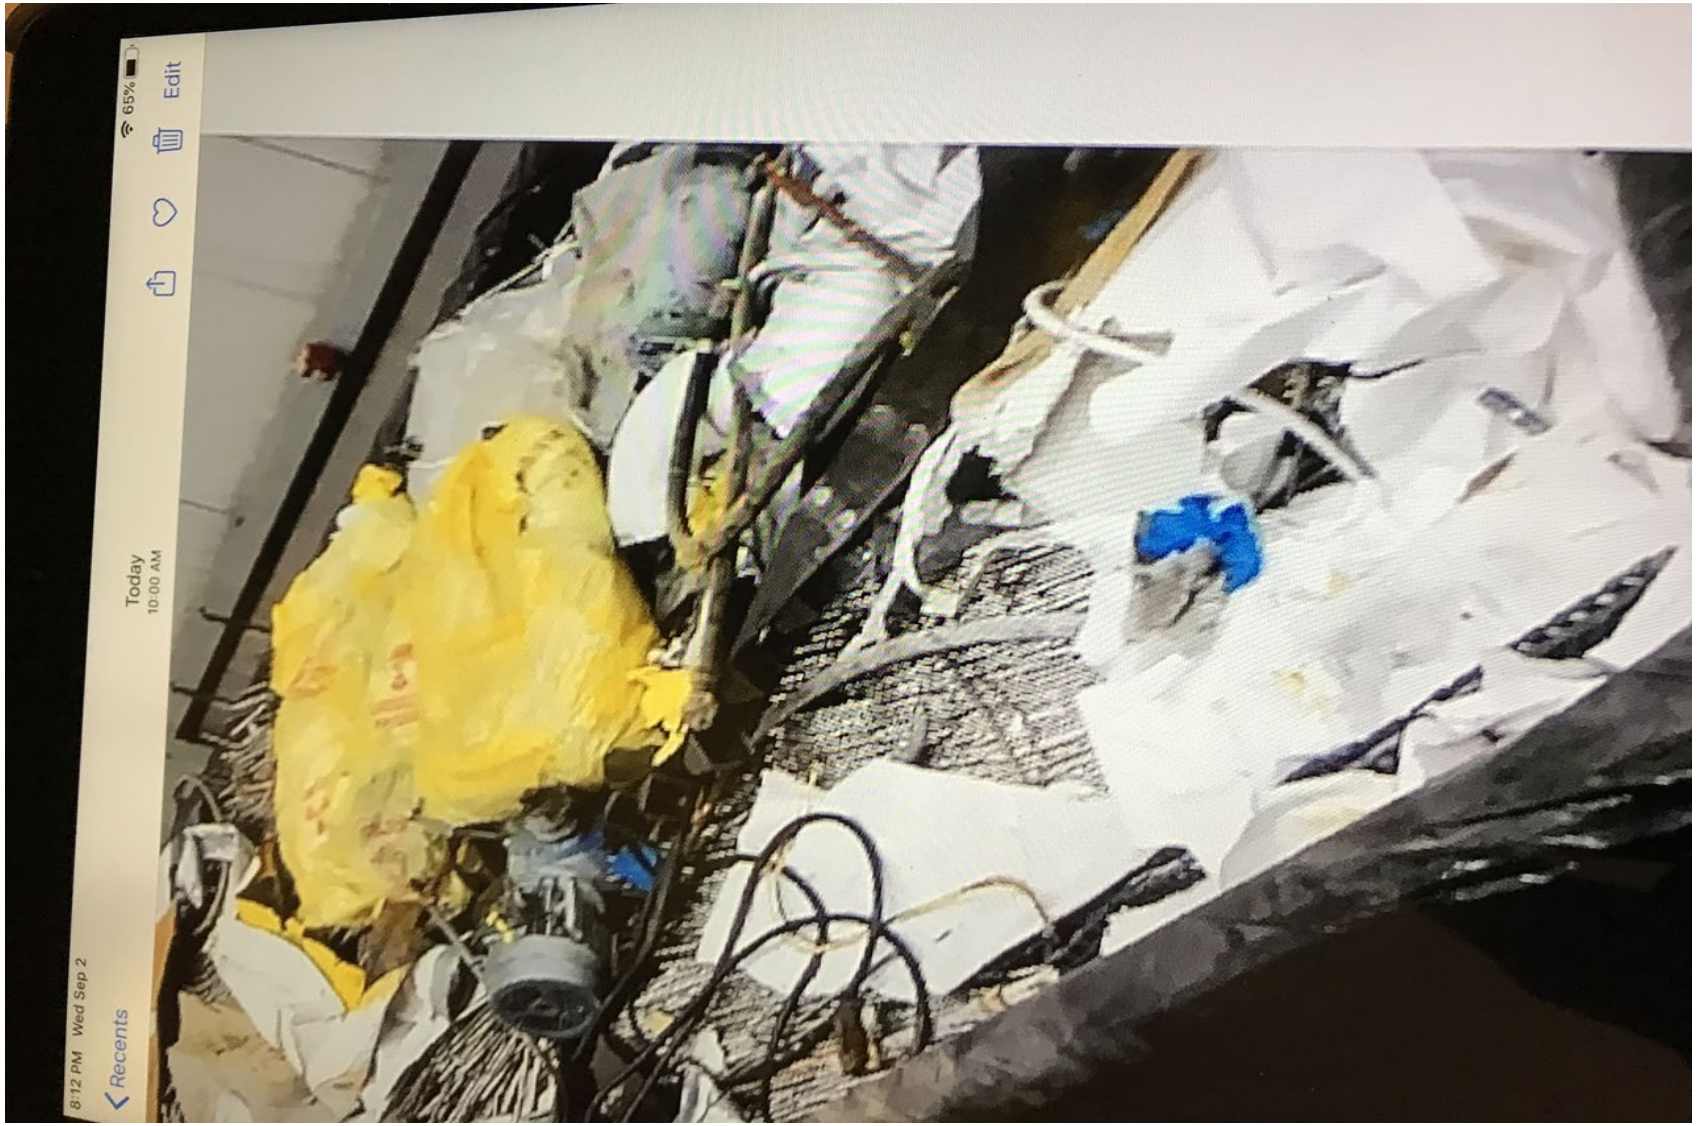
- There were no special handling instructions provided from the shipper or conveyed on the shipping documents with the shipping of these Zircalloy rods. The Zirc Rods were found piled on top of each other in the car when the transloading/remediation began.

Photograph of the loaded car provided by the shipper before the fiberglass lid was applied

- This investigation also proved that the shipper improperly loaded this car by allowing the Zirconium Rods to interact with other Zirconium Rods and other metal objects, despite information of the SDS for this material. This metal-to-metal contact created friction through movement in transportation that caused the rods to create filings. Those Zirconium filings are the most volatile and they created the sparks that ignited the combustible dunnage that was loaded in the void spaces between the rods and other metal objects in the car.

- We are recommending that packaging standards be developed for Zirconium, Zircalloy and all other derivatives of Zirconium that demonstrates pyrophoric properties be required to be separated and/or blocked and braced by regulation so they cannot interact with other Zirconium or other metals while in transportation.
